Manhole Inspection Summary

Manhole # S35WW_026MH

Insp Date: **1/9/07 10:02 AM**

Location Address: **3050 ABELL AVE**

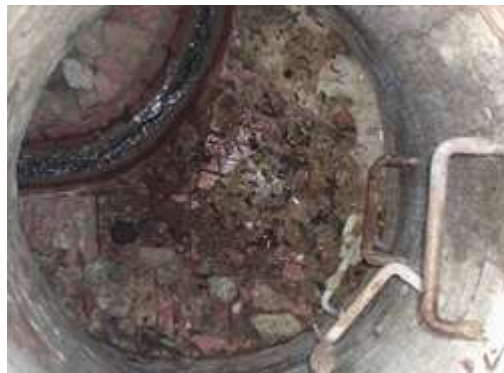
Top View

Corroded steps. Evidence of surcharge - Bench debris.

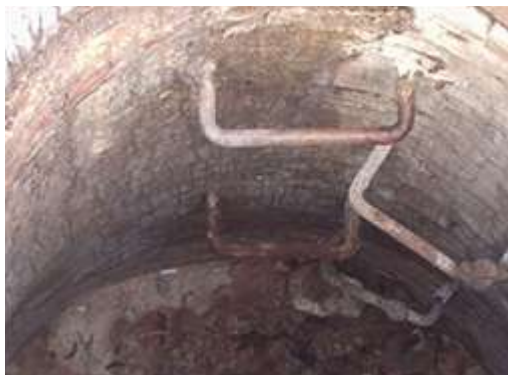
Defect

Barrel infiltration.

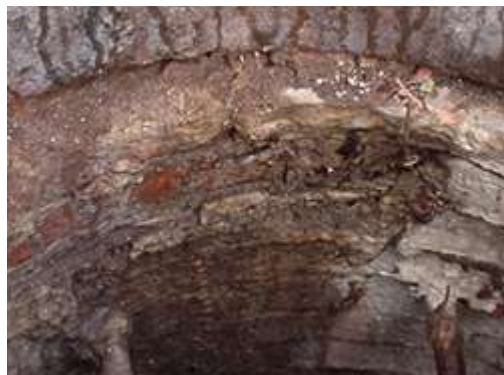
Defect

Frame offset. Adjustment deterioration, cracks and infiltration.

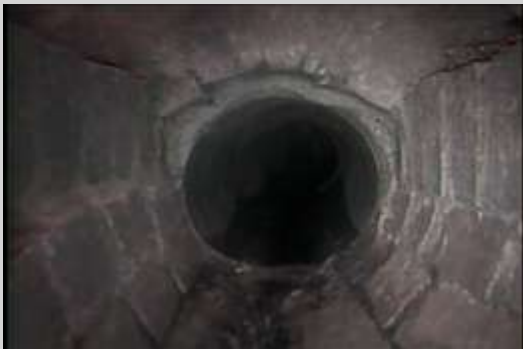
8 in. Circular Gravity Sewer Pipe In @ 9 O'Clock

Infiltration: **Evidence** Pipe Seal Cond: **Unknown**
